Mitsubishi Slave Cylinder MD748617 Modification

This instruction applies to twin clutches using Mitsubishi slave cylinder-MD748617. Mitsubishi Evo 4-9MR, Mazda FD3S, Honda S2000 AP1, AP2, and Honda NSX NA1, NA2

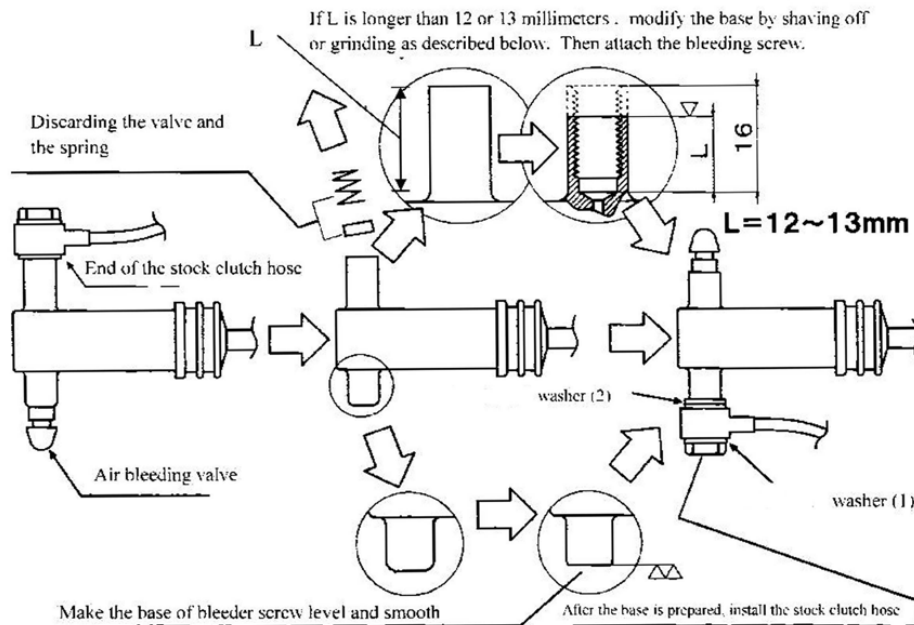
Since early 2007, an oil leak from the air bleeder valve has been reported several times after it was modified based upon the instructions provided by us. The cause of the leak turned out to be the new height of the bleeder base described "L" in the diagram below. The height of the bleeder base has been increased by several millimeters and the top of the air valve does not reach the seal bottom without further modification.

1. Measure the height of the base "L" with calipers.
2. If "L" is 16mm, modify the height of the base by shaving of 3-4mm. Then insert the air bleeding screw.
3. If "L" is 12-13mm, no modification is necessary. Insert the air bleeding screws.
